**Flood Control Project Maintenance
Levee Inspections**

Fall 2012 Levee Maintenance Deficiency Summary Report

Sacramento River Basin

Sacramento Maintenance Yard Willow Slough Bypass

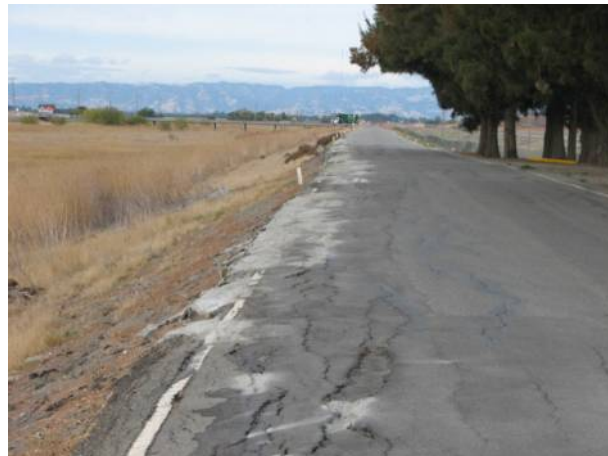
Levee Mile Report Line	5
Start Levee Mile	0.07
End Levee Mile	0.21
Location	Water Side
Category	Earthen Levee
Item	Cracking

There is still cracking sloughing on the waterside crown. Attempts to fill in the cracks all along the roadway have been done.

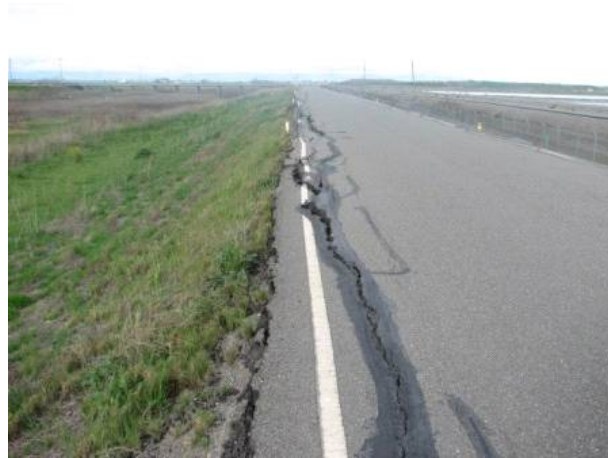
Levee Mile Report Line	6
Start Levee Mile	0.34
End Levee Mile	0.36
Location	Water Side
Category	Earthen Levee
Item	Cracking
Photo taken spring 2012, cracking along the waterside shoulder.	
johngw_f_20120911_694.jpg

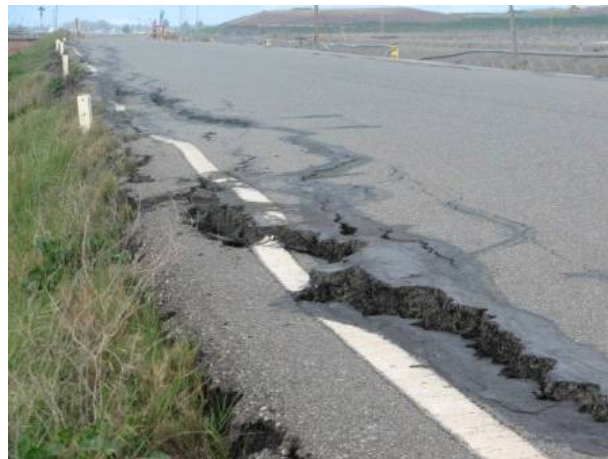
Levee Mile Report Line	6
Start Levee Mile	0.34
End Levee Mile	0.36
Location	Water Side
Category	Earthen Levee
Item	Cracking
Photo taken 2012, the shoulder has fallen 4"-6" in depth.	
johngw_f_20120911_695.jpg

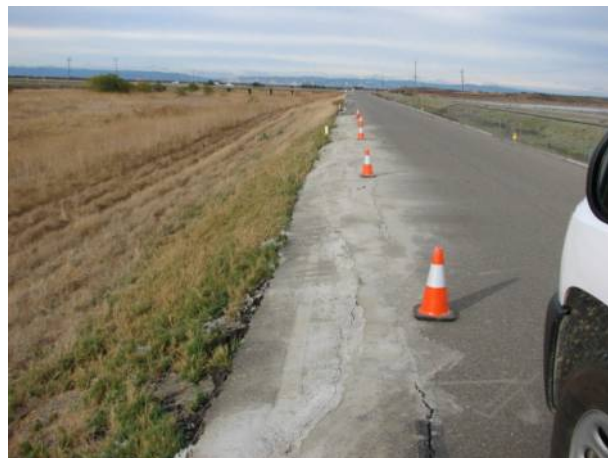
Levee Mile Report Line	6
Start Levee Mile	0.34
End Levee Mile	0.36
Location	Water Side
Category	Earthen Levee
Item	Cracking
This is the worst area and it has been cosmetically fixed. Fall 2012	
johngw_f_20121105_828.jpg

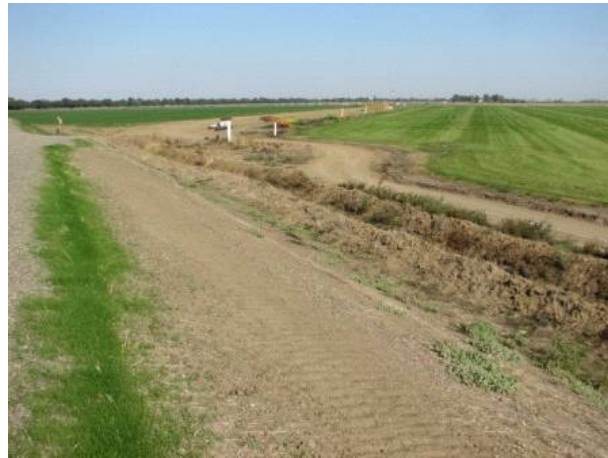
Levee Mile Report Line	7
Start Levee Mile	4.16
End Levee Mile	4.63
Location	Land Side
Category	Earthen Levee
Item	Encroachments

The agricultural ditch runs along the toe of the levee. Fall 2011

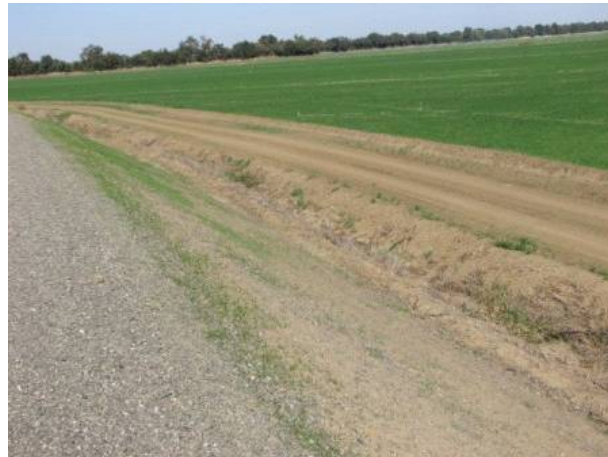
Levee Mile Report Line	7
Start Levee Mile	4.16
End Levee Mile	4.63
Location	Land Side
Category	Earthen Levee
Item	Encroachments

Another view of the agricultural running along the toe of the levee. Fall 2011

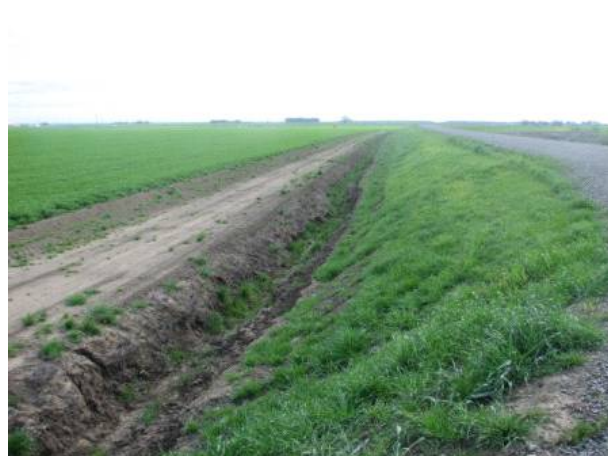
Levee Mile Report Line	7
Start Levee Mile	4.16
End Levee Mile	4.63
Location	Land Side
Category	Earthen Levee
Item	Encroachments

Photo take spring 2012, agricultural ditch along landside toe.

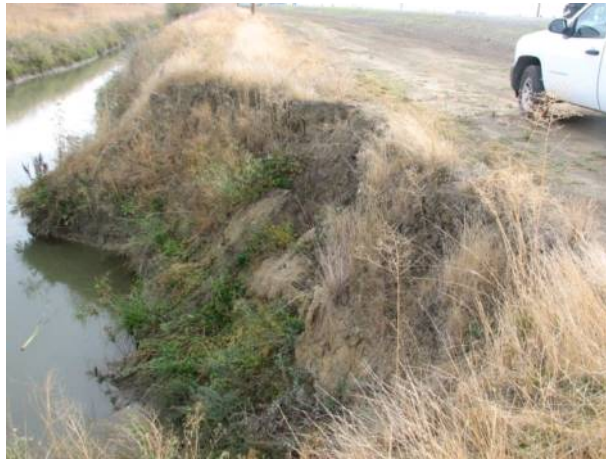
Levee Mile Report Line	1
Start Levee Mile	1.71
End Levee Mile	1.71
Location	Water Side
Category	Earthen Levee
Item	Erosion / Bank Caving

Erosion on the edge of the channel. Fall 2012

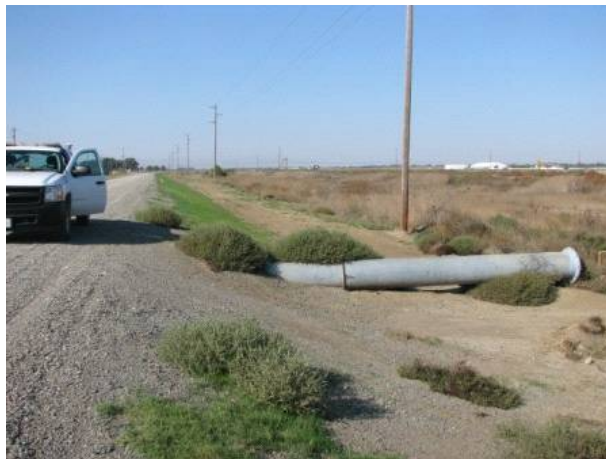
Levee Mile Report Line	2
Start Levee Mile	1.86
End Levee Mile	1.86
Location	Water Side
Category	Earthen Levee
Item	Encroachments

A pipe crossing thru the levee and blocking toe road. Fall 2011

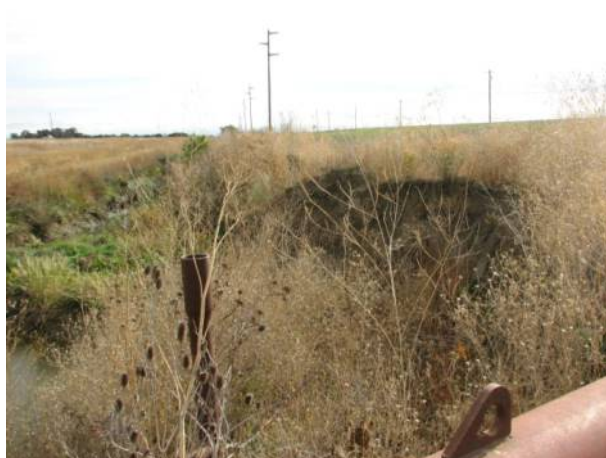
Levee Mile Report Line	3
Start Levee Mile	1.86
End Levee Mile	1.86
Location	Water Side
Category	Earthen Levee
Item	Erosion / Bank Caving

Erosion on the edge of the channel. Fall 2012

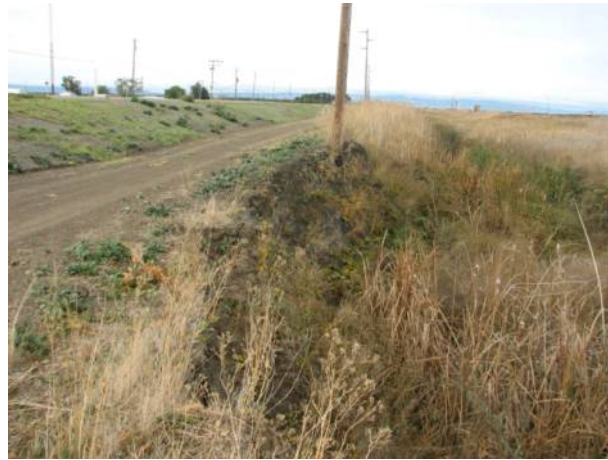
Levee Mile Report Line	4
Start Levee Mile	1.97
End Levee Mile	1.97
Location	Water Side
Category	Earthen Levee
Item	Erosion / Bank Caving

Erosion on the edge of the channel. Fall 2012.

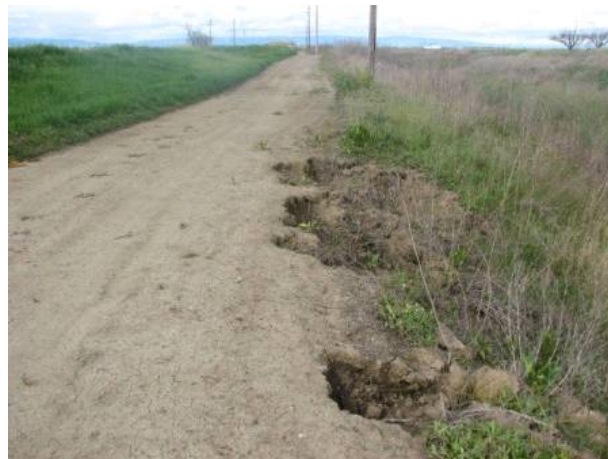
Levee Mile Report Line	5
Start Levee Mile	2.66
End Levee Mile	2.66
Location	Water Side
Category	Earthen Levee
Item	Erosion / Bank Caving

DWR ID: DWR_ST0012_02_s_2012_5										
5	2.66	2.66	Earthen Levee	Erosion / Bank Caving	WS	M Ma	E1 : Note and monitor erosion site. Inspector Comments: The erosion is starting to encroach into the toe road.	38.589714 ° -121.709456 °	38.589714 ° -121.709456 °	9 Y
DWR ID: DWR_ST0012_02_s_2012_9										
6	2.90	2.90	Earthen Levee	Erosion / Bank Caving	WS	M Ma	E1 : Note and monitor erosion site. Inspector Comments: The site has a discharge pipe and has begun eroding around the pipe. It is also eroding into the toe road.	38.589707 ° -121.705044 °	38.589707 ° -121.705044 °	10 Y
DWR ID: DWR_ST0012_02_s_2012_10										
7	3.56	3.56	Earthen Levee	Encroachments	LS A/W	BU : Building En	Inspector Comments: Control structure for Davis Drain block building	38.589657 ° -121.692850 °	38.589657 ° -121.692850 °	2 Y
DWR ID: DWR_ST0012_02_s_2012_2

Photo taken spring 2012, the eroision encroaches into the toe road.

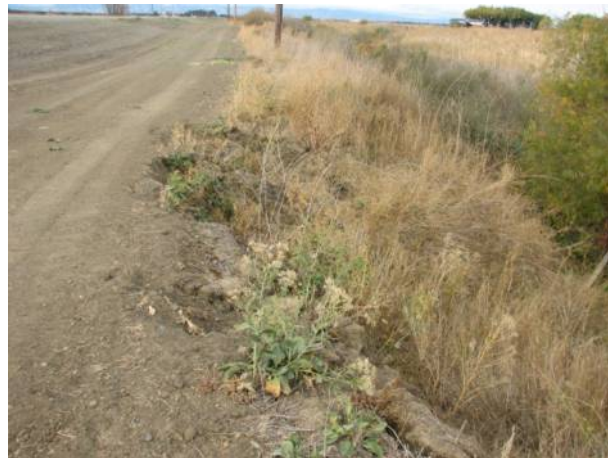
Levee Mile Report Line	5
Start Levee Mile	2.66
End Levee Mile	2.66
Location	Water Side
Category	Earthen Levee
Item	Erosion / Bank Caving

Erosion on the edge of the channel. Fall 2012

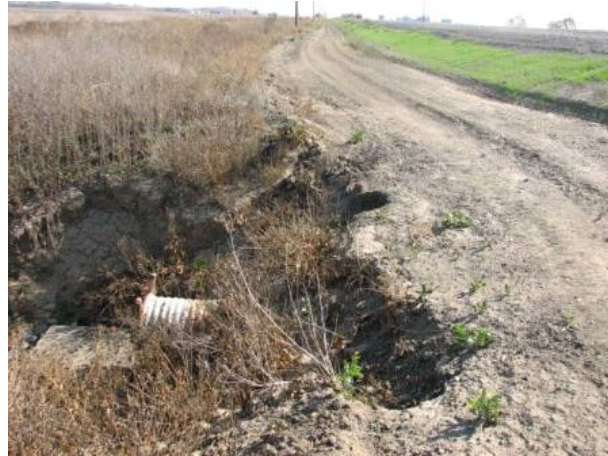
Levee Mile Report Line	6
Start Levee Mile	2.90
End Levee Mile	2.90
Location	Water Side
Category	Earthen Levee
Item	Erosion / Bank Caving

The slope around the discharge pipe is eroding the toe road. Rip rap could be placed around the pipe and re-sloped. Fall 2011

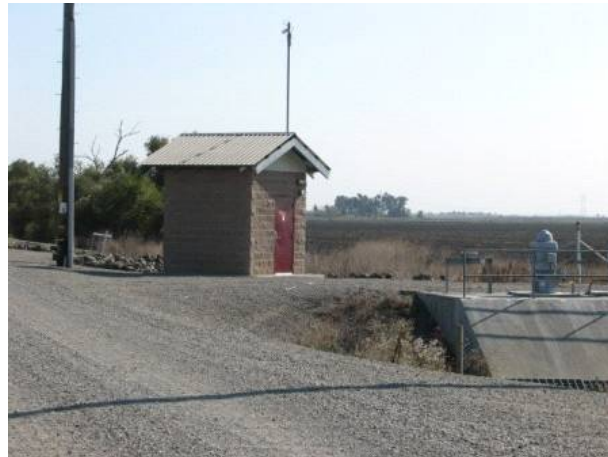
Levee Mile Report Line	7
Start Levee Mile	3.56
End Levee Mile	3.56
Location	Land Side
Category	Earthen Levee
Item	Encroachments

A control structure is placed on top of the levee. Fall 2011
